# Manhole Inspection Summary

Manhole # S19G\_\_035MH

Insp Date: **9/20/07 11:10 AM**

**Location** Address: **2211 LEXINGTON-VINE**

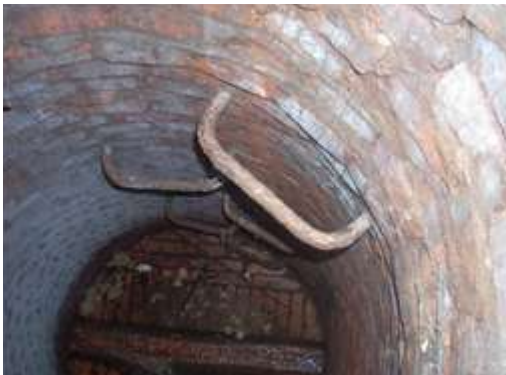
Defect 3

**Steps** Count: **5** Missing: **0** ☒ **Corroded**

CORRODED STEPS

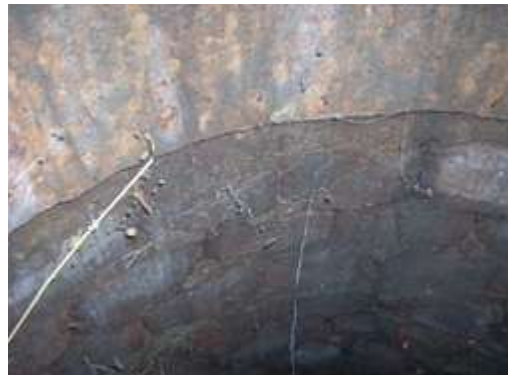
Defect 2

Condition: ☐ Sound ☐ Cracked ☒ **Root Intrusion** ☐ Loose Brick ☐ Deteriorated

ROOT INTRUSION ON CORBEL

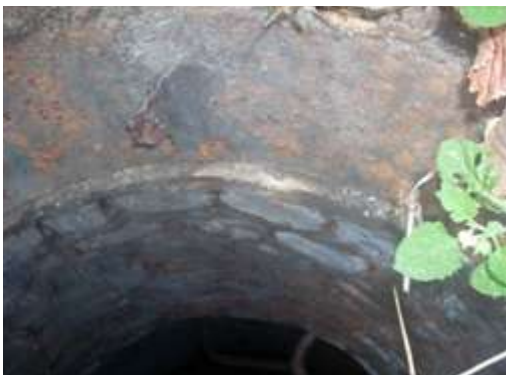
Defect 1

**Frame** Offset: **0.5** (in.) Condition: ☒ Sound ☐ Cracked ☐ Leaks

FRAME OFFSET

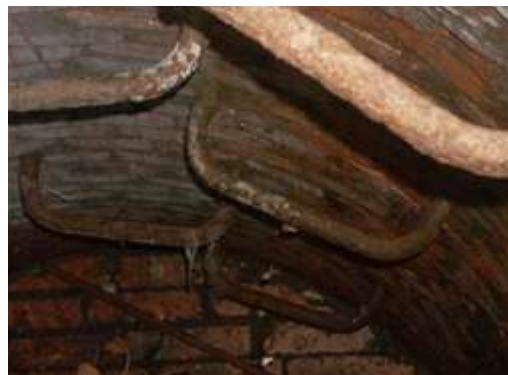
Defect 4

**Surcharge** ☒ **Evidence Of Surcharge** Depth: **5** (ft.) ☐ Active Surcharge Present

SURCHARGE EVIDENCE ON THE STEPS
